Report on visit to four proposed sites in Ciudad Juarez

Summary: Members of the administrative unit of the air quality monitoring fund (Ricardo Aragon, Cesar Fierro and Sergio Vasquez), the Mexican co-president (Ing. Oscar Fentanes), and researchers from the Autonomous University of Ciudad Juarez (UACJ) visited four proposed sites on March 23, 2022 for the installation of a new air quality monitoring station in Ciudad Juarez.

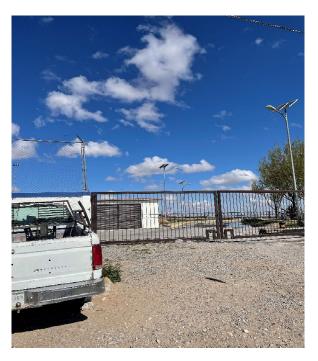
Picture 4 - Entrance to the site, there is security 24/7

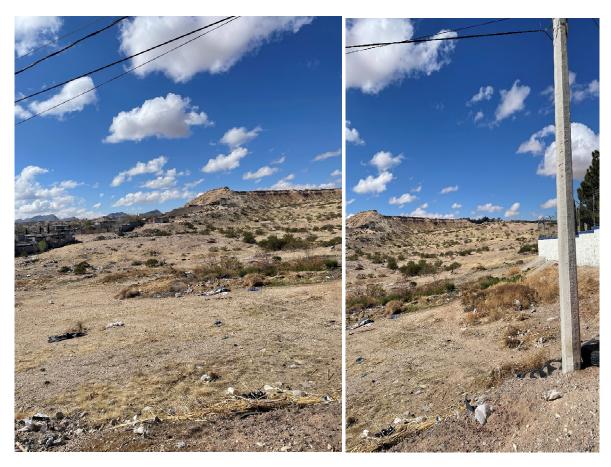
Picture 5 – There is not much around the site

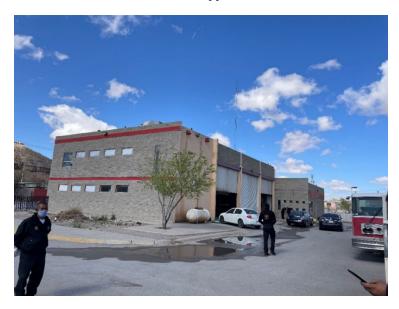
Advantages		Disadvantages	
1.	Site has electricity	1.	It may be more expensive to install
2.	There are several options on where		station on top of fire station.
	the station can be placed. One option	2.	It is required to install an electrical
	is above the fire station (must confirm		connection of approximately 100m/
	the structure of the building, see		109 yards to provide electricity to
	picture 9) and the other is in the		station.
	corner of the property (see Picture	3.	We must install the modem and
	10)		contract the service to be able to
			have internet connection at the
			station.
		4.	If station is placed at ground level, we
			must build a concrete slab to level the
			floor.
		5.	Current equipment on site has been
			stolen and site has been vandalized.
			Security is not very secure.
		6.	Limited growth

Picture 9 – Fire Station, site can be placed on top

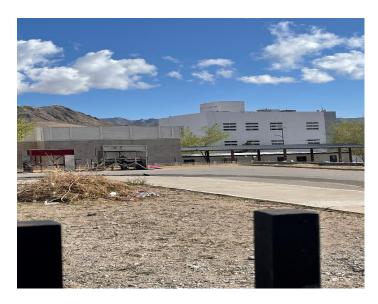
Picture 10 – Monitoring station can be placed on the corner of the site.

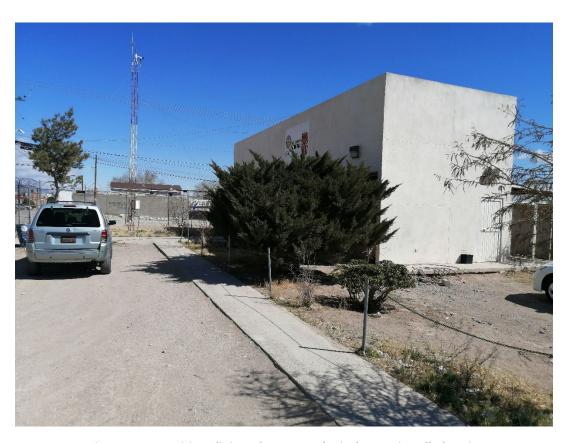
3. It can become an operational center	
with various monitoring equipment.	
UACJ will install their ceilometer at	
this site and there is a meteorological	
tower currently at the site.

Picture 14 – Nutrition Clinic and a meteorological tower installed at site

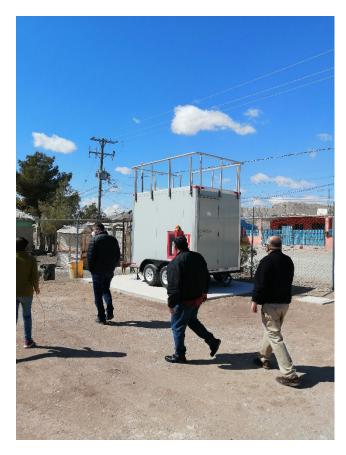
Picture 15 – Monitoring Equipment at site

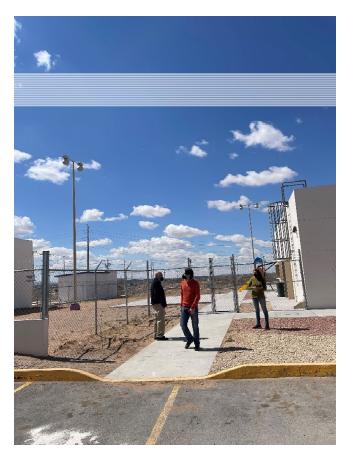
Picture 20 – Fence, left side of community center
